Supplier Name & Code	BURTON POWER LTD.
Part Name	FOOT-REST MOULDING
Part No.	49874/5 NX44G

Report No.	SUP2013-33		
Rank	B		
Incident Date &	08/05/2013		
Time			
Model	X11E		
Quantity Affected	1		
Affected Lot No's.			
Recurrence	Y	✓	N

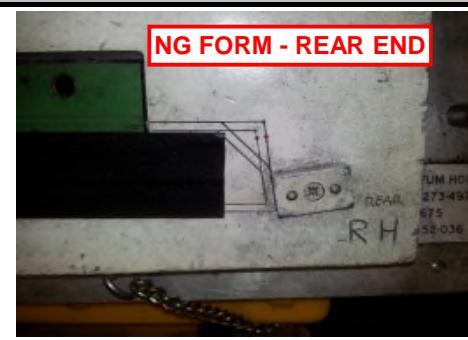
1 off Concern part found measured too short.

1	Why was the non conformity made?	2	3	4	Why was the non conformity not detected? (Press 2)	5	Why was the non conformity not detected? (Final inspection jig)
Why?	1 off Concern part found measured too short.	Why?	Why?	Why?	1 off Concern part found measured too short.	Why?	1 off Concern part found measured too short.
Why?	Because: The parts was not in the correct position when the press was cycled.	Why?	Why?	Why?	Note: This is a 2 press process. Press 1 cuts the location tabs and press 2 cuts the end lengths. Because: The part was not detected during the end cut operation on press 2.	Why?	Because: The concern part was not identified on the final inspection jig
Why?	Because: When the part has been placed in the tool, the ejector has been fully extended.	Why?	Why?	Why?	Because: The tool which cuts the part to the correct length has 2 poka yoke switches, one at the front and another at the rear, these detect that the part is in the correct position. These were not effective for the concern part.	Why?	Because: On completing a line review with the operator it was discovered that the SOP was not being following as written. As a result, the error (short part) was not identified to the operator.

Why?	Because: The cycle from the previous pressing had not completed and the ejector had not returned home.	Why?	Why?	Why?	Because: On investigation no issues were found with the poka yoke switches which means that the short part was not detected due to the poka yoke switches being overridden.	Why?	Because: The operator, at some point in time had started doing the check away from the SOP.

Because: Due to issues with the press, it is currently being run in 'inch' mode and not automatic. Note: Even with the press in 'inch' mode the poka yoke switches are active.	Why?		Why?		Because: The operator did not understand why the press would not cycle and therefore used the override key.	Why?	
Root Cause:							
1 Operator manually overriding Poka Yoke switch and not controlling the resultant part.	2 Resp. JC Dept. Prod		3 Resp. Dept.		4 Resp. Dept.	5 Resp. JC Dept. Prod	SOP not followed due to lack of training.

Actions		Resp.	Dept.	Timing
1) Complete a full 4M audit of the line, including training records and SOP's.		MR	QA	10-May
2) Re-create concerns. Secondary line review to be completed with the tool in the press to interrogate why 2 set of Poka Yoke appeared to have failed.		MR	QA	10-May

3) Complete a briefing ensuring that operators on B33 are clear what the procedure is when dealing with 'Non Standard work'. (ie press stopping without completing its cycle)		JC	Prod	10-May

4) Review with the operators the use of the final checking fixture and its related SOP.		JC / MR	Prod / QA	10-May
5) Modify the SOP for the final checking jig to be in line with the current process.		JC	Prod	21-May

6) Modify the final checking jig so that any error, short or long, will be detected. (Red Zone both sides)		JC	Prod	21-May
7) Tally chart to be created which will record how often the key is being used to override the poka yoke switches. This will run for a period of 2 weeks with all of the data being passed to tool room / maintenance to generate an improvement plan.		JC	Prod	17-May
